COLORADO CULTURAL RESOURCE SURVEY

Architectural Inventory Form

Rev. 9/98

| 48. Report title: | Town of Telluride Re-Survey of Historic Structures | | Planning and Building

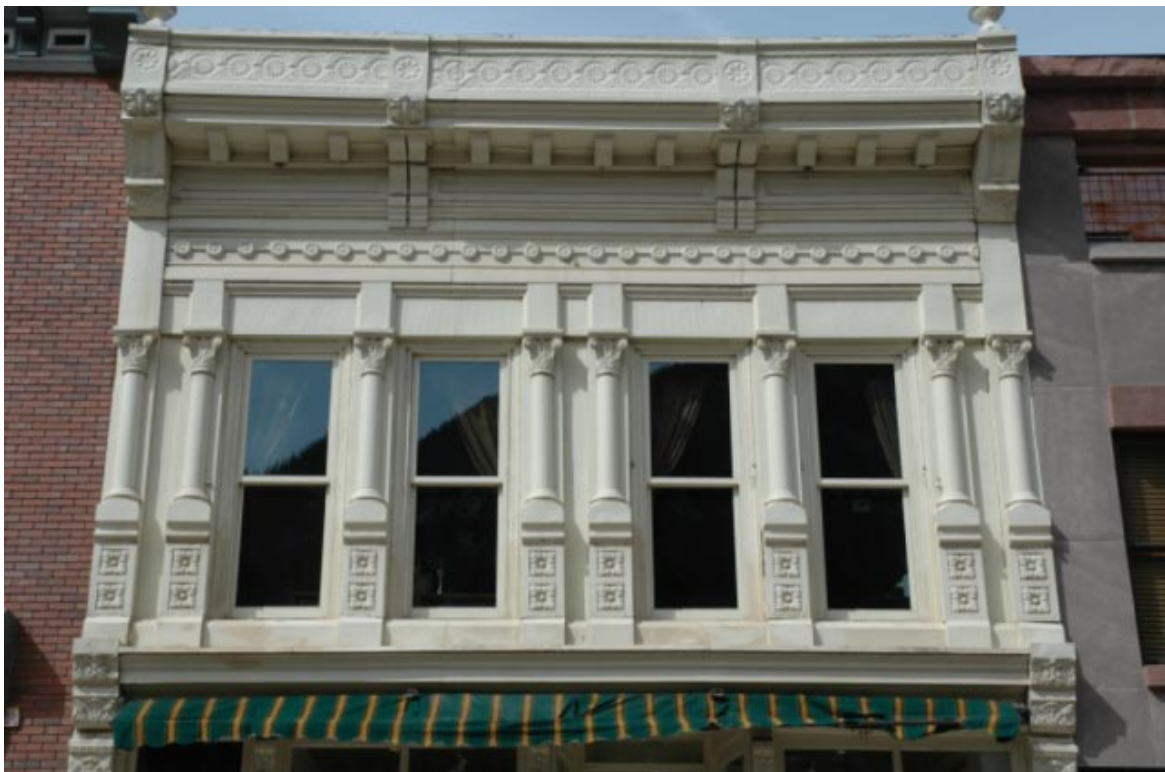
21. General architectural description:
The Mahr Building in downtown Telluride is a prominent two-story commercial building, with an ornate cast iron façade obtained from Mesker Brothers of St. Louis. Erected in 1892, the building's cast iron façade is nearly symmetrical, and fronts directly onto the concrete sidewalk paralleling Colorado Avenue on the south elevation. Comprising a single storefront, the façade's first story is composed of a recessed entryway flanked by single-light fixed-pane storefront display windows. A painted cream white glass in-wood-frame door, with a transom light, enters the building from within the recessed entryway, while the flanking windows also feature transom lights, as well as painted cream white wood paneled kickplates. A painted cream white wood-paneled door with a transom light is located at the west end of the façade. This door provides access to an interior staircase leading to the second story. A plaque fastened to this door's locking rail includes the following text:
